# Professional Home Inspections

## Our Inspection Report

LOCATED AT:  
4437 North 55th Street  
Racine, Wisconsin 53402

INSPECTED ON:  
Friday, December 2, 2022

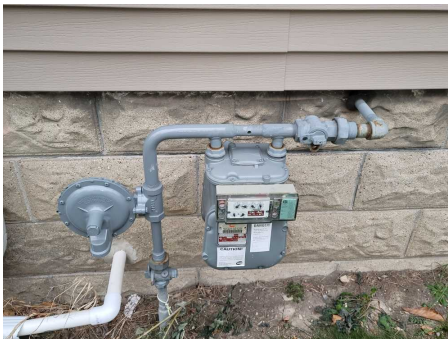
Gas meter

- 19:** The gas meter is outside on the right side of the building. The main gas supply shutoff valve is located on the riser pipe between the ground and the meter. This valve should be turned 90 degrees (either way) in order to shut off the gas.

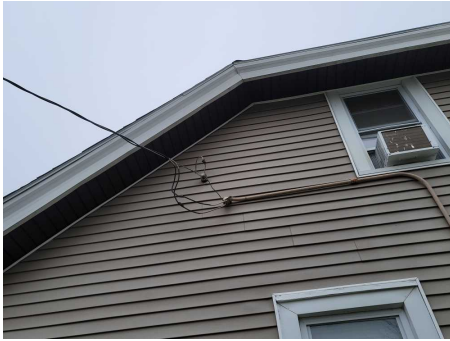
**20:** The service drop appears to be properly installed and in good condition.

Service drop

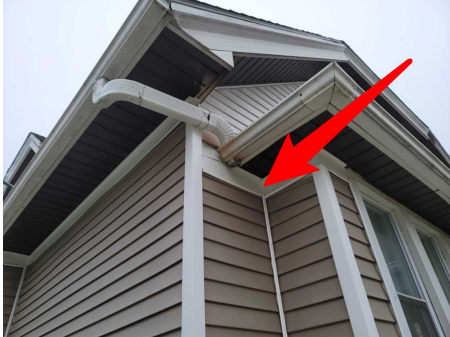
**WARN 30:** One or more of the downspouts is missing. The water coming from the scuppers will splash and damage exterior siding and finishes. Downspouts are also necessary to channel runoff away from the building. We recommend missing downspouts be replaced.

Missing downspout

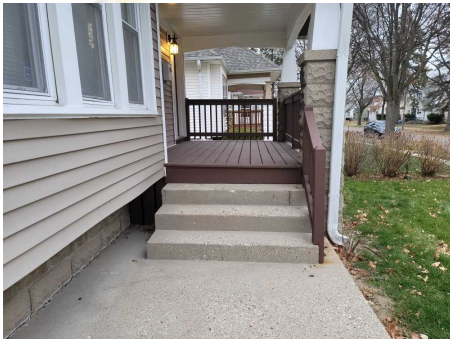
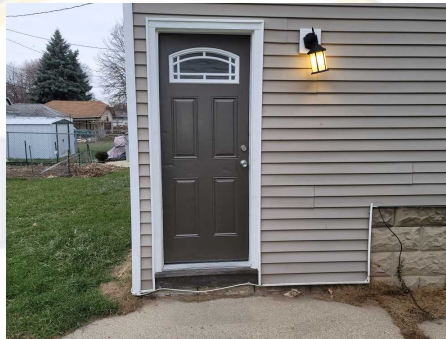
**31:** The exterior stairs appear to be properly constructed and are in serviceable condition.

Steps to the building

West side steps to the building

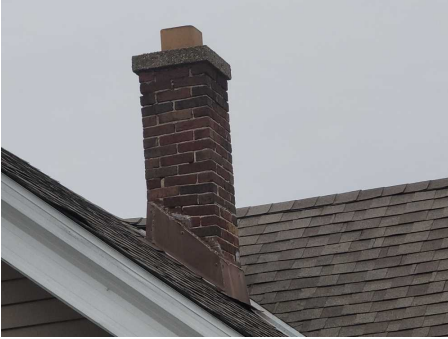
**34:** The chimney appears to be in good condition. No major problems were observed that would affect the satisfactory operation of the fireplace.

Chimney structure

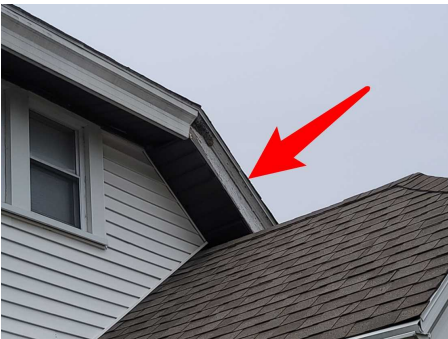
**WARN 37:** Sections of the fascia at the north side are damaged. We recommend they be repaired or replaced.

Missing flashing

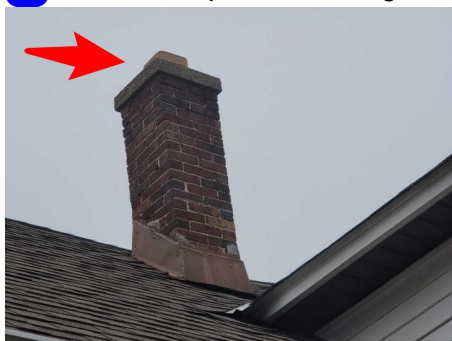
**UPG 46:** Flue caps are missing. We recommend they be replaced to keep out rain and debris.

Flue cap missing

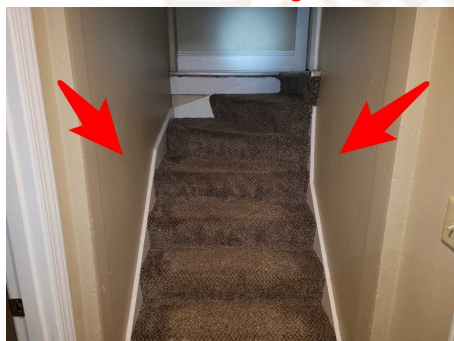
**DNGR 66:** There are no railings where needed at the stairs going to the basement. As a safety measure, we recommend that railings be installed.

Missing handrails

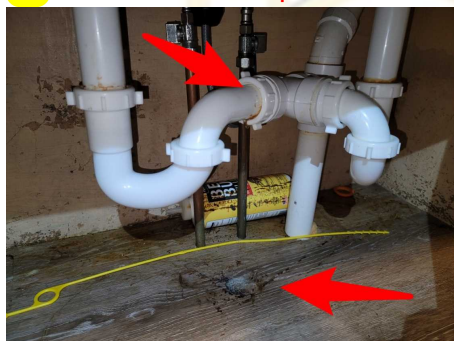
**WARN 84:** The drain trap connections were leaking. We recommend that it be repaired or replaced.

Drain trap, water leakage observed

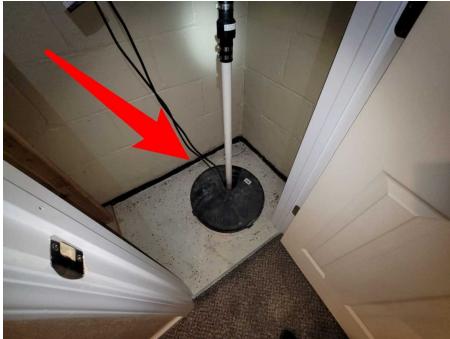
Sump pump

**231:** A sump pump has been installed to remove occasional water from the sump. The pump was not tested under normal working conditions, but the motor was found to be in working condition.

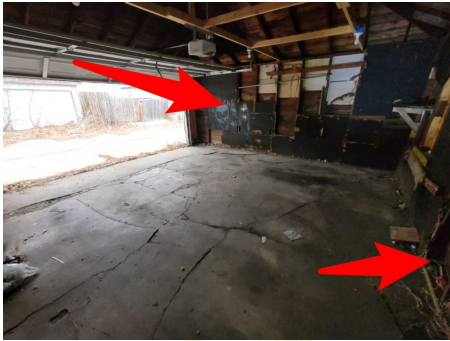
**WARN 257:** The wall framing in the garage at the bottom damaged areas observed. Changes in use or other conditions could lead to additional damage or failure. We recommend the framing be repaired or replaced in accordance with present standards.

Damaged areas observed

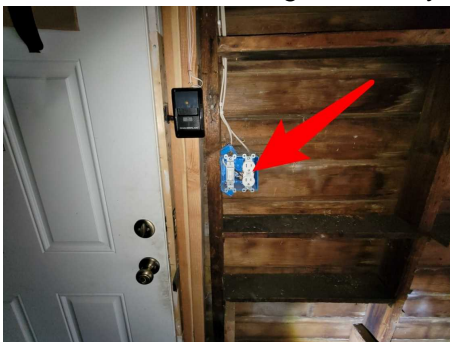
**UPG 258:** GFCI PROTECTION: There is no GFCI (ground fault circuit interrupter) protection for this area. For an increased margin of safety, we recommend the installation of a GFCI receptacle.

Missing faceplate

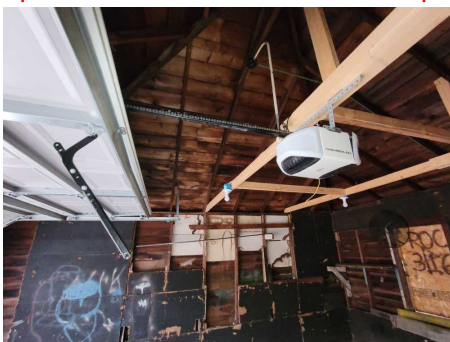
**WARN 259:** The garage door opener failed to respond to normal operating controls. We recommend the opener and/or the controls be repaired or replaced.

Failed to respond

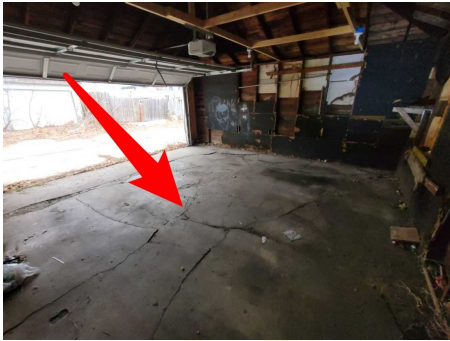
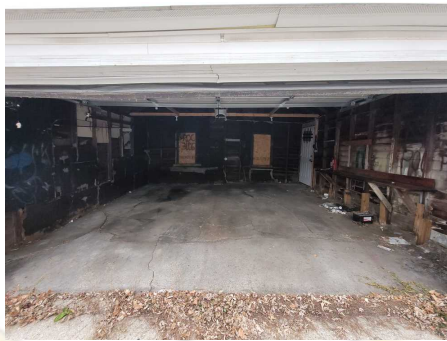
**261:** There are cracks in the floor slab with minor vertical displacement of the slab toward the middle of the garage. This is not a reflection on the condition of the rest of the building. No action is indicated.

**RECO 262:** There are large cracks in the floor slab. These are basically cosmetic considerations and action is considered optional. However, this condition does indicate movement in the soil and additional floor movement can be expected in the future.

Concrete slab

Garage slab
